Technical Report CHL-99-3
March 1999

Monitoring Completed Navigation Projects Program

Inspections of Previously Monitored Coastal Structures

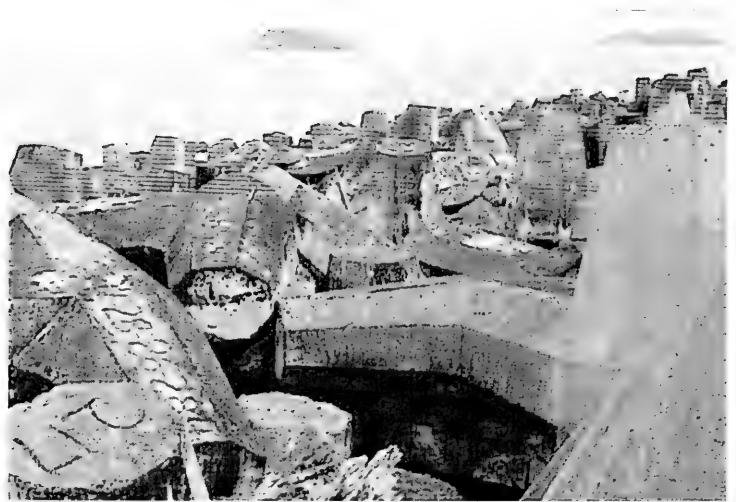
The Crescent City Harbor breakwater (Figure 27) was inspected on 15 September 1998. The inspection indicated that most of the armor unit positions were similar to those shown in the 1993 photography as close as could be observed visually. It appeared that only a couple of the 38,100-kg (42-ton) units had changed positions slightly along the waterline at the outer portion of the main stem. Figure 28 shows some of these units at the head of the main stem of the breakwater. Numerous broken armor units were observed, but were validated as being broken in the 1993 survey. Overall the structure is in good condition.

Figure 28. View of 38,100-kg (42-ton) dolosse on the sea-side slope of the main stem of the Crescent City breakwater

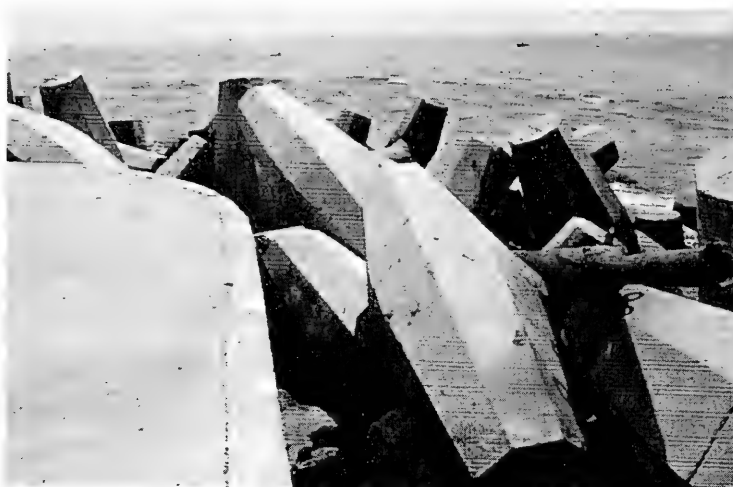
The Manasquan Inlet jetties were inspected on 10 June 1997. The 14,515-kg (16-ton) dolos armor units are shown in Figure 49. Visual comparisons of armor unit positions on the north jetty to 1994 photomaps revealed that several units had moved slightly. Horizontal movement appeared to range from 0.15 to 0.6 m (0.5 to 2 ft). In addition, it appeared that the downslope portions of most of these units had slightly lost

Figure 49. 14,515-kg (16-ton) dolos armor units on Manasquan Inlet jetties

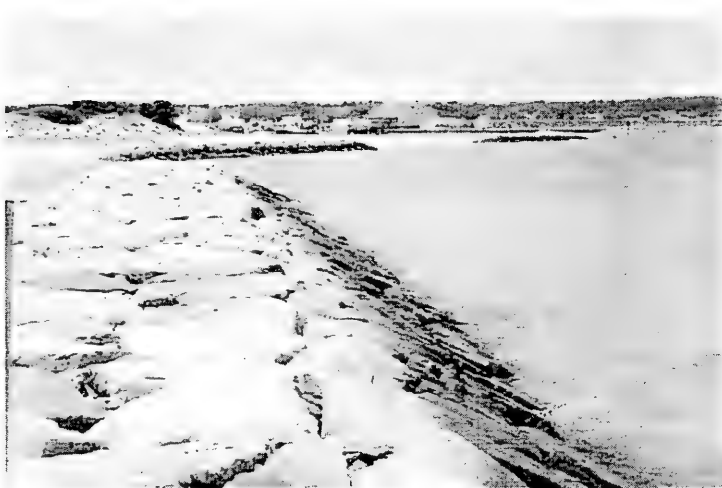
The rehabilitated south jetty and headland breakwaters at Ocean City Inlet were inspected on 11 June 1997. The rehabilitated south structure is shown in Figures 54 and 55, and the headland structures are shown in Figure 56. The inspection revealed these structures to be in excellent condition. No voids were noted, no armor stones were broken, and the cross sections of the structures appeared to be as built. It was noted that the seaward section of the old south jetty (that extending beyond sta 13+00) was in disarray. Armor stones were scattered, the crest height was inconsistent, and no definite cross section was apparent (Figure 57).

Figure 56. Headland breakwaters at Ocean City Inlet constructed to stabilize shoreline
